NASA TM X-73390

## INVESTIGATIONS FOR THE IMPROVEMENT OF SPACE SHUTTLE MAIN ENGINE ELECTRON BEAM WELDING EQUIPMENT

By R. A. Smock, R. A. Taylor, and W. A. Wall

April 1977

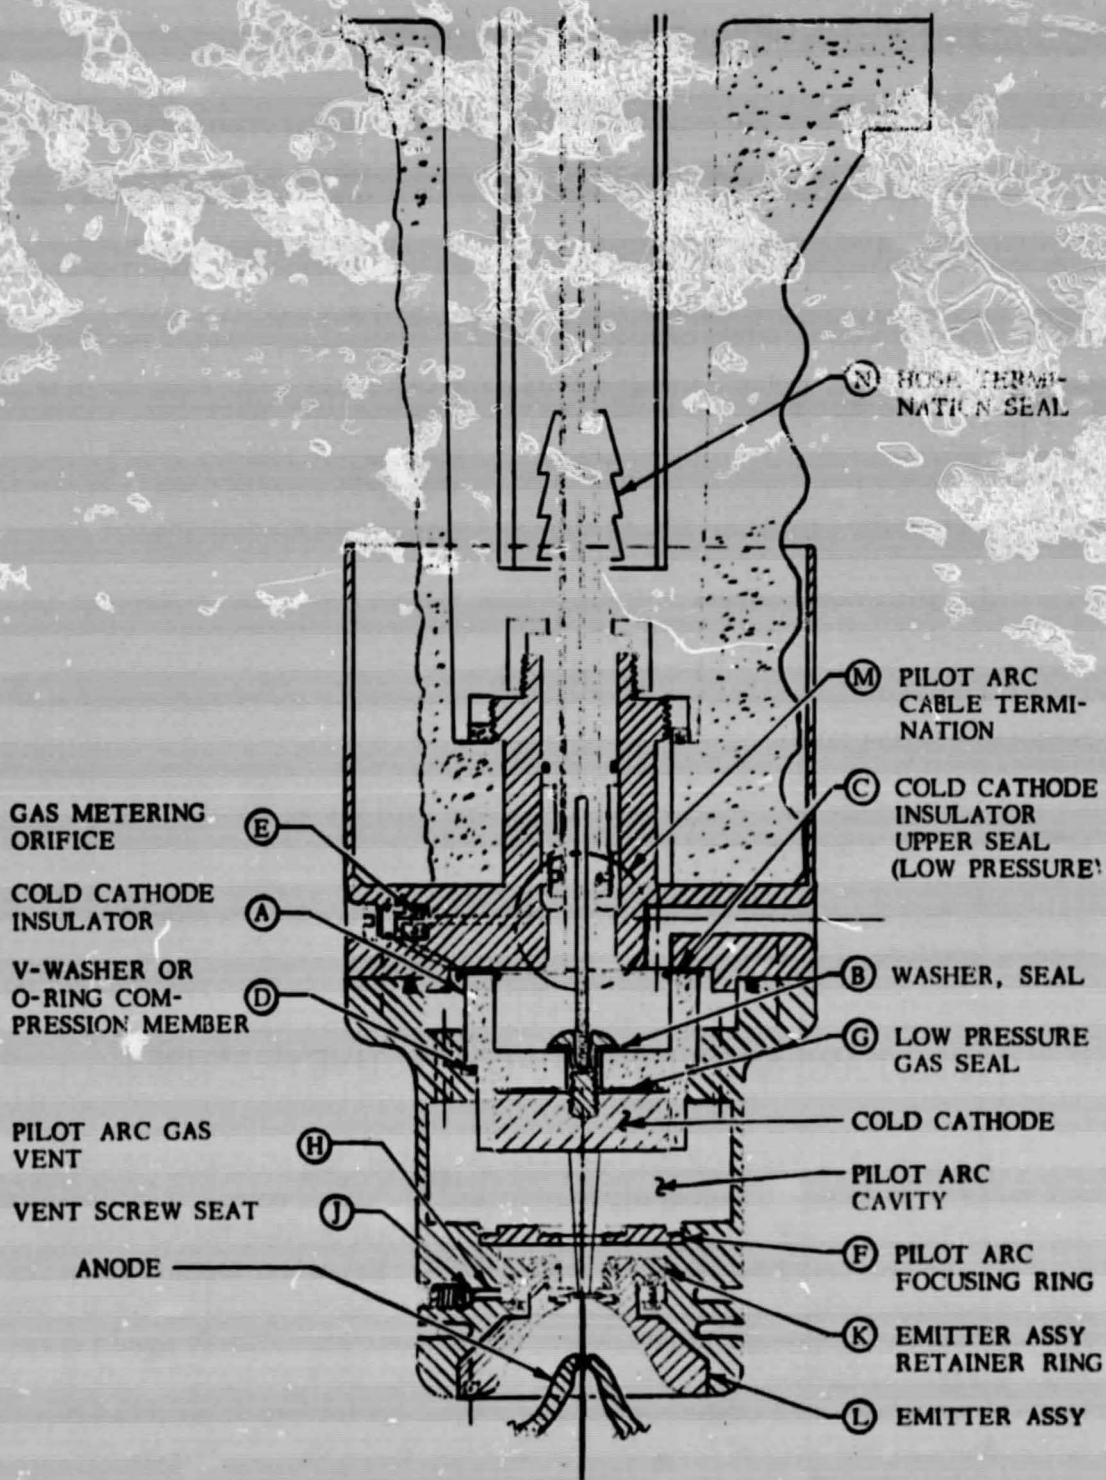
Figure 3. Cross section, EB gun.

When the EB gun (Fig. 3) was disassembled, the pilot arc chamber was found to be severely coated with carbon and aluminum oxide. This indicated extensive impingement of the pilot arc on the electron emitter holder carbon washers and erosion of the pilot arc cold cathode. Relatively thick rings of nonsymmetrically deposited thin film carbon were visible on the aluminum cold cathode, indicating that the pilot arc was not as symmetrical as it should be. Also, streaks of carbon vapor deposition on the back side of the cold cathode insulator at A indicated slight gas leakage around the lead washer seal at B. Other faults in this area of the gun were that the lead seal at C leaked, the compression Viton O-ring at D would not stand the heat causing it to lose

resilience, and the 0.0127 mm (0.0005 in.) diameter nitrogen gas metering orifice at E was almost totally clogged with a foreign metallic substance. The orifice required soaking in a solution of nitric acid to remove the restriction but was later replaced with a new orifice disk to meet the flow requirements of 40 to 60 bubbles/min. Modifications to the gun proper are as follows with reference to Figure 3:

1. The pilot arc chamber and focusing ring F were thoroughly cleaned with sodium hydroxide and polished. It was learned that deposits of aluminum oxide on the focusing ring aperture tend to cause defocusing and dissymmetry of the pilot arc. This causes partial impingement of the pilot arc on the carbon tungsten emitter washer rather than totally upon the tungsten emitter. This condition results in poor pilot arc efficiency as evidenced by loss of output weld current and carbon impolution.

2. Graphoil (A UCC product) seals were used to replace lead washers at B and C to prevent leakage of nitrogen pilot arc gas and resultant erratic gun operation. In the past, the lead seals in these locations were coated with a light coating of vacuum grease prior to installation. However, the Graphoil seals work best installed dry. Also, it has been found that vacuum grease, when heated, offgasses and contaminates the pilot plasma arc causing erratic gun operation. It also dries, flakes, and clogs the 0.0127 mm (0.0005 in.) orifice.

4. An Inconel V-washer (Figure 4a) was used to replace the Viton O-ring at D to maintain sealing pressure at C. Actually, the maintenance of sealing compression at C is one function of the O-ring, or V-ring, at D. The other function is to cushion the cold cathode ceramic insulator.

6. For consistent control and finer adjustment of the pilot arc gas vents at J, the following modifications were made:

- a. Gas vent ports at H were enlarged to 2.18 mm (0.086 in.) diameter.

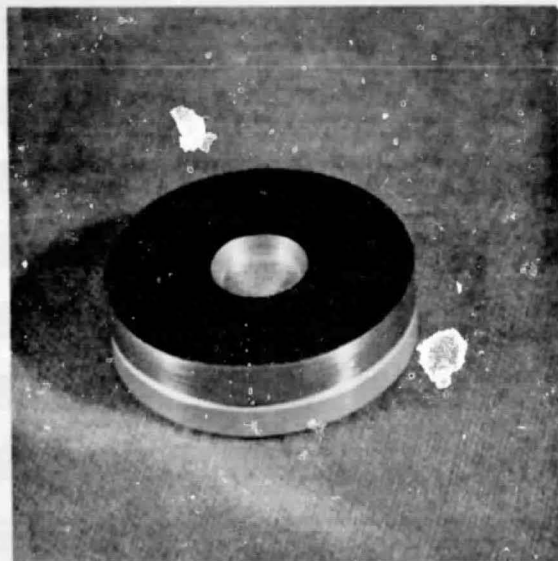
d. Titanium-aluminum cold cathode. Titanium face shown up.

Once all of these changes were incorporated into the gun, start-up problems were resolved. However, it was still apparent that the cold cathode configuration needed improvement. This was evidenced by (1) operational values of pilot arc relative power (percent) greater than factory recommended, (2) excessive carbon and aluminum oxide vapor deposit accumulation in the pilot arc cavity, and (3) suspected arcing from the cold cathode to the gun internal wall. At the suggestion of UCC, a Lanthanum Hexaboride,  $\text{LaB}_6$ , cold cathode

was procured and tried. Before the cold cathode could be tested, UCC discovered a flaw in the design and recommended changing to aluminum-titanium as shown in Figure 4d. UCC provided a cold cathode of aluminum-titanium for test purposes. It was theorized that titanium, being a poorer electron emitter than aluminum at gun operating temperatures, would help prevent arcing between the cold cathode and gun wall. The aluminum disk exposed in the center of the titanium-aluminum cathode is the actual cold cathode emitter material. Pilot arc power for the given beam current range was reduced to UCC recommended levels, and the pilot arc relative power for different electron beam power levels repeated consistently. All indications are that focusing and distribution of the pilot arc are now stable and operate as the gun developer intended. The titanium-aluminum cathode, as received from UCC, proved satisfactory and, therefore, the proposed testing of the LaB<sub>6</sub> cathode was omitted.

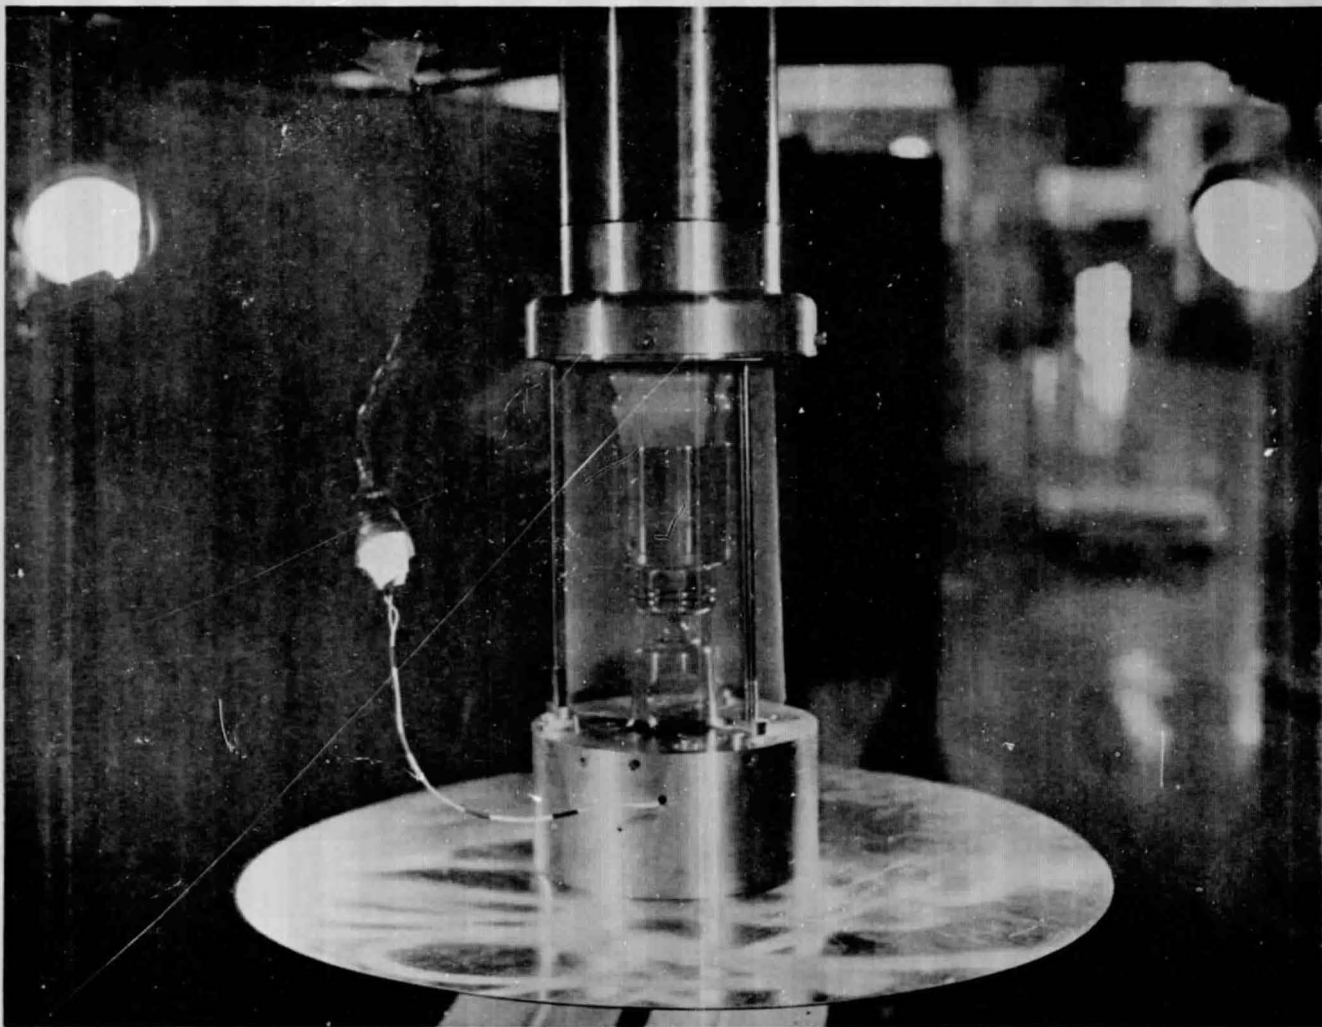
Figure 6. ERI EB gun open, see-through fixture with focus coil.

After stabilization of the gun, the next goal was to locate and eliminate, or at least minimize, sources of flashover (arcing) at the machine's rated voltage of 60 kV. During operation, frequent arcs would occur causing the EBW to shut down. These arcs were very prevalent during the standard 60 kV cleanup procedure. Since the gun housing completely enclosed the gun, visual observations during operation were impossible. To maintain alignment of the cathode and anode, a sturdy "see-through" fixture (Fig. 6) with anode-to-emitter alignment provisions was designed, fabricated, and installed. Provisions were also made to install the focus coils on the new fixture. The screen wire was necessary to maintain a uniform electrical field distribution around the gun. A uniform electrical field prevents corona buildup and an eventual arc. Also, the large round shield at the bottom of the fixture was provided to prevent metal vapors from depositing on the gun's high voltage insulator. Use of this fixture enabled us to determine if most arcs causing machine shutoff were external or internal to the EB gun. Since most flashovers at operating voltages in the 55 to 60 kV range were visually determined to be from the cathode to the copper anode, it was decided to try an anode made from low electron emitting material such as titanium. A drawing of the anode was obtained from UCC, and four titanium anodes were fabricated. It was theorized that titanium, being a nitrogen getter and a poor electron emitter, would absorb nitrogen which is known to leak around the hot tungsten emitter and help prevent small pockets of ionized gas from forming on the anode. As expected, the newly machined titanium anode arced profusely to the cathode during the normal 60 kV cleanup procedure. However, once purged of foreign materials and lightly trapped surface gases, operation

was excellent and probably superior to copper from the viewpoint of arc suppression. No anode overheating was observed, or evident, and pitting due to arcs was minimal — much less than previously observed with copper anodes. The question of titanium versus copper anodes, though, has not yet been thoroughly tested or evaluated.

While the special fixture was being used, the interior surfaces of the gun housing were honed and lapped to a mirror finish to improve the gun-to-housing dielectric characteristics. In addition, a new, highly polished corona shield was added to the gun. The relatively sharp edges on the new shield, as received from UCC, were rounded and polished to a mirror finish and then satisfactorily tested in the open fixture. To verify if the EB gun would now operate as "arc-free" in the polished standard housing as it did in the open, "see-through" fixture, the gun was reassembled in the newly polished housing and tested. With the gun mounted vertically, ten 2 min runs and twelve shorter duration runs were made within a time span of less than 90 min. A total of 23 min of operation was thus achieved with the gun operating at the power supply full rated power of 60 kV and 125 mA. One arc-out occurred during this 23 min of testing, causing the equipment to shut down normally. This test was repeated a second time with substantially the same results. Thus, operating time between arc-outs at 60 kV tested approximately 20 times better than when the investigation first started. Previously the welder would rarely operate for more than 1 min at 55 to 60 kV without an arc-out. Further testing is planned, but these results indicate that the gun operated in the polished standard 30 kW rated housing essentially equal to its operation in the open fixture with the gun mounted vertically. Orientation is mentioned because horizontal operation of the ERI EB gun is not normally quite as free from arcs as when the gun is mounted vertically.
